# ENVIRONMENTAL ASSESSMENT

**SSG GUS KEFURT  
U.S. ARMY RESERVE CENTER (OH069)  
399 MILLER STREET  
YOUNGSTOWN, OHIO 44507-1591**

**U.S. Army Corps of Engineers  
Engineering Division  
Louisville District**

**APRIL 2001**

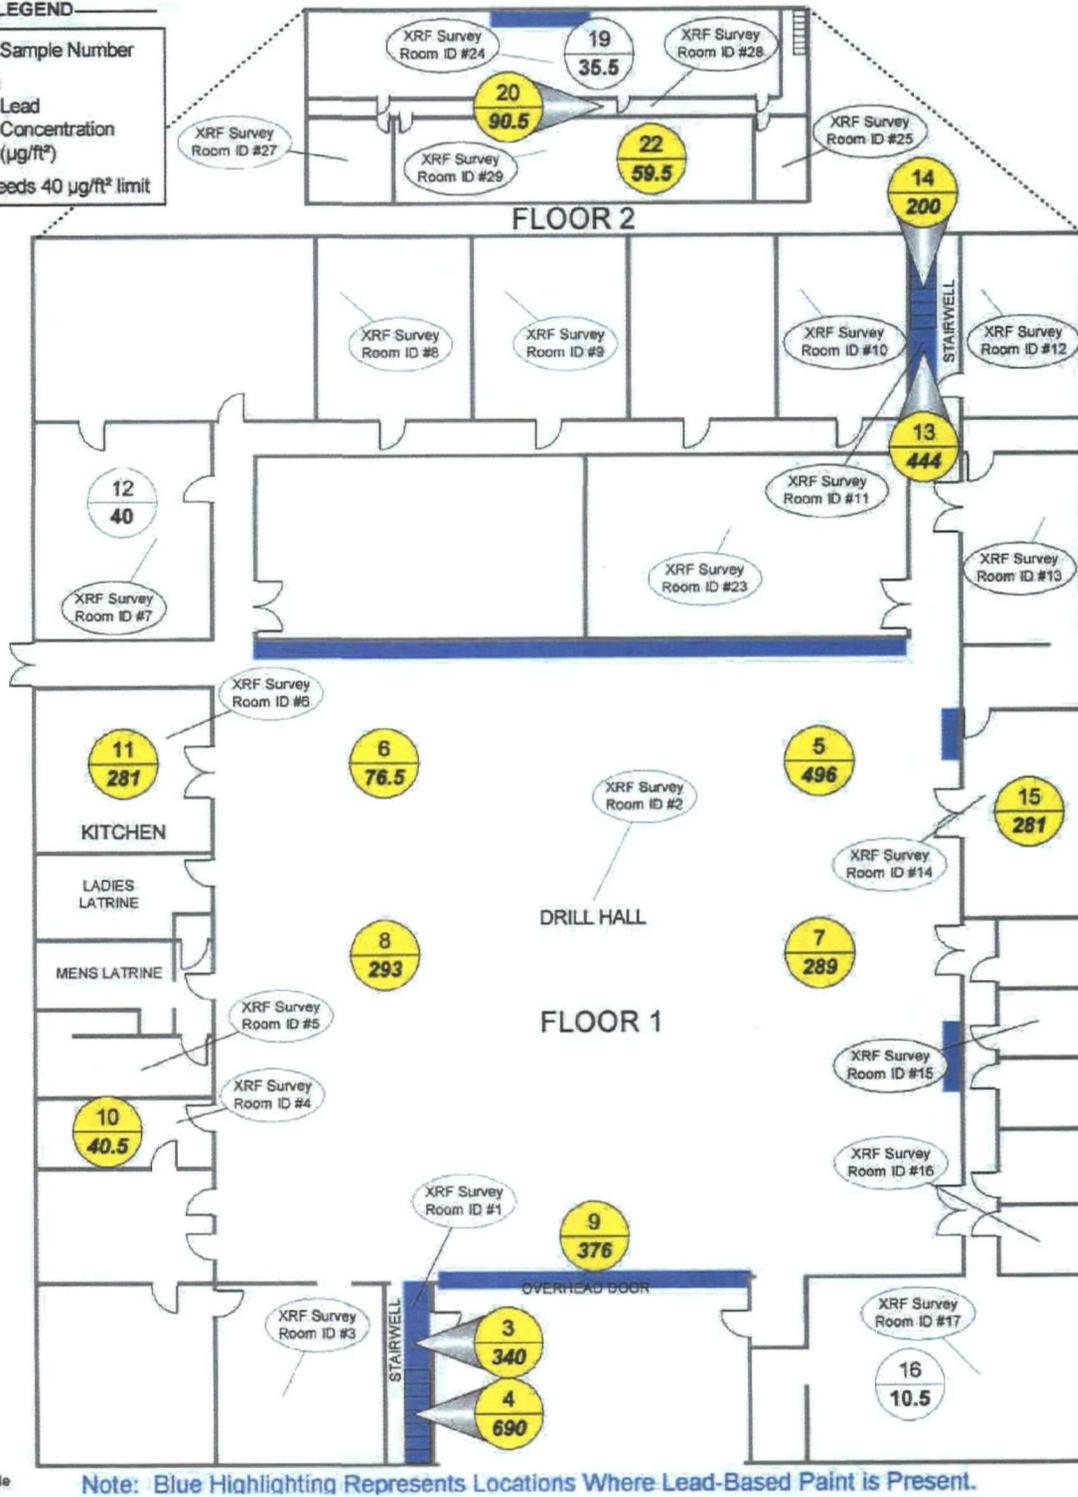
**FIGURE 3**

**LOCATIONS OF LEAD-BASED PAINT RELATIVE TO LOCATIONS OF ELEVATED LEAD IN FLOOR DUST SAMPLES – FIRST FLOOR**

A comparison of the locations of LBP relative to the locations of elevated levels of lead on the floor showed good correlation. Figures 3 and 4 in Appendix B depict locations of LBP relative to the locations of elevated levels of lead in floor dust samples. The highest concentrations of lead dust were located in areas that also contained LBP, which included the stairwells and drill hall. Overall, ten of the 16 locations having elevated levels of lead dust were located in rooms or areas that contained LBP. Of the six locations that could not be directly attributed to LBP, three were in rooms that were directly connected to the drill hall. Two other locations were on the second floor, which can only be accessed by the northern stairwell. Given the close proximity of these five locations to areas having the highest concentrations of lead dust, the presence of the lead dust at these locations can be attributed to foot traffic from the stairwells and drill hall. The

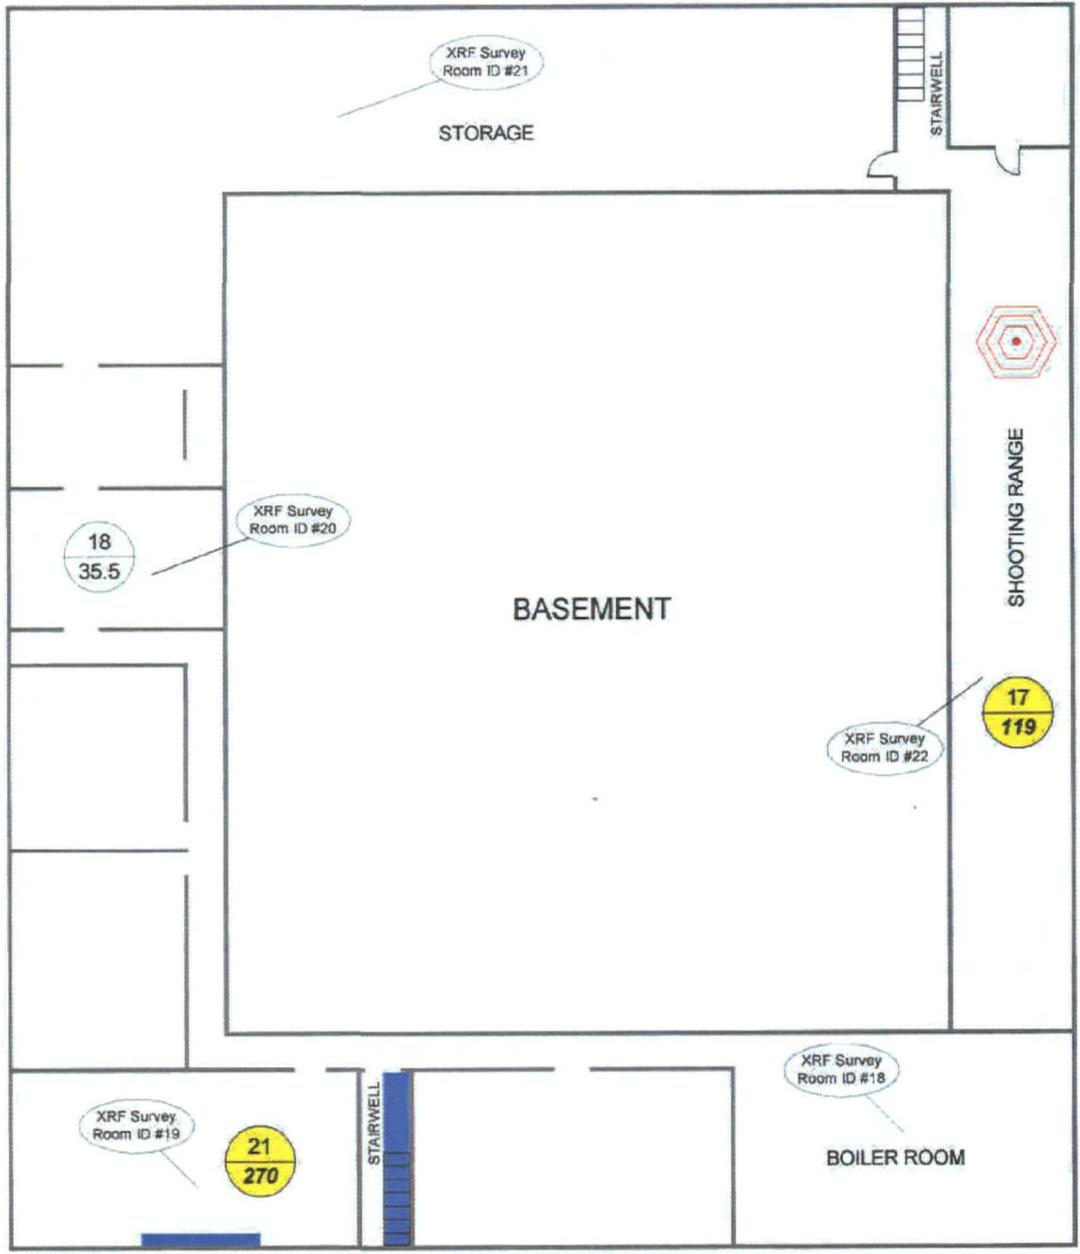
FIGURE 4

Note: Blue Highlighting Represents Locations Where Lead-Based Paint is Present.

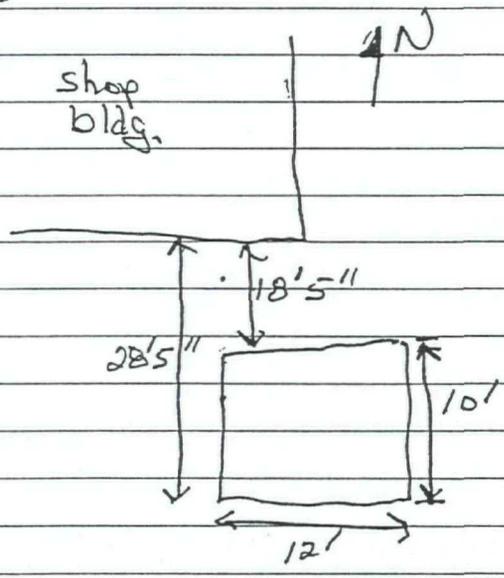
grade to water 5'  
 grade to excavation bottom 5' 6"

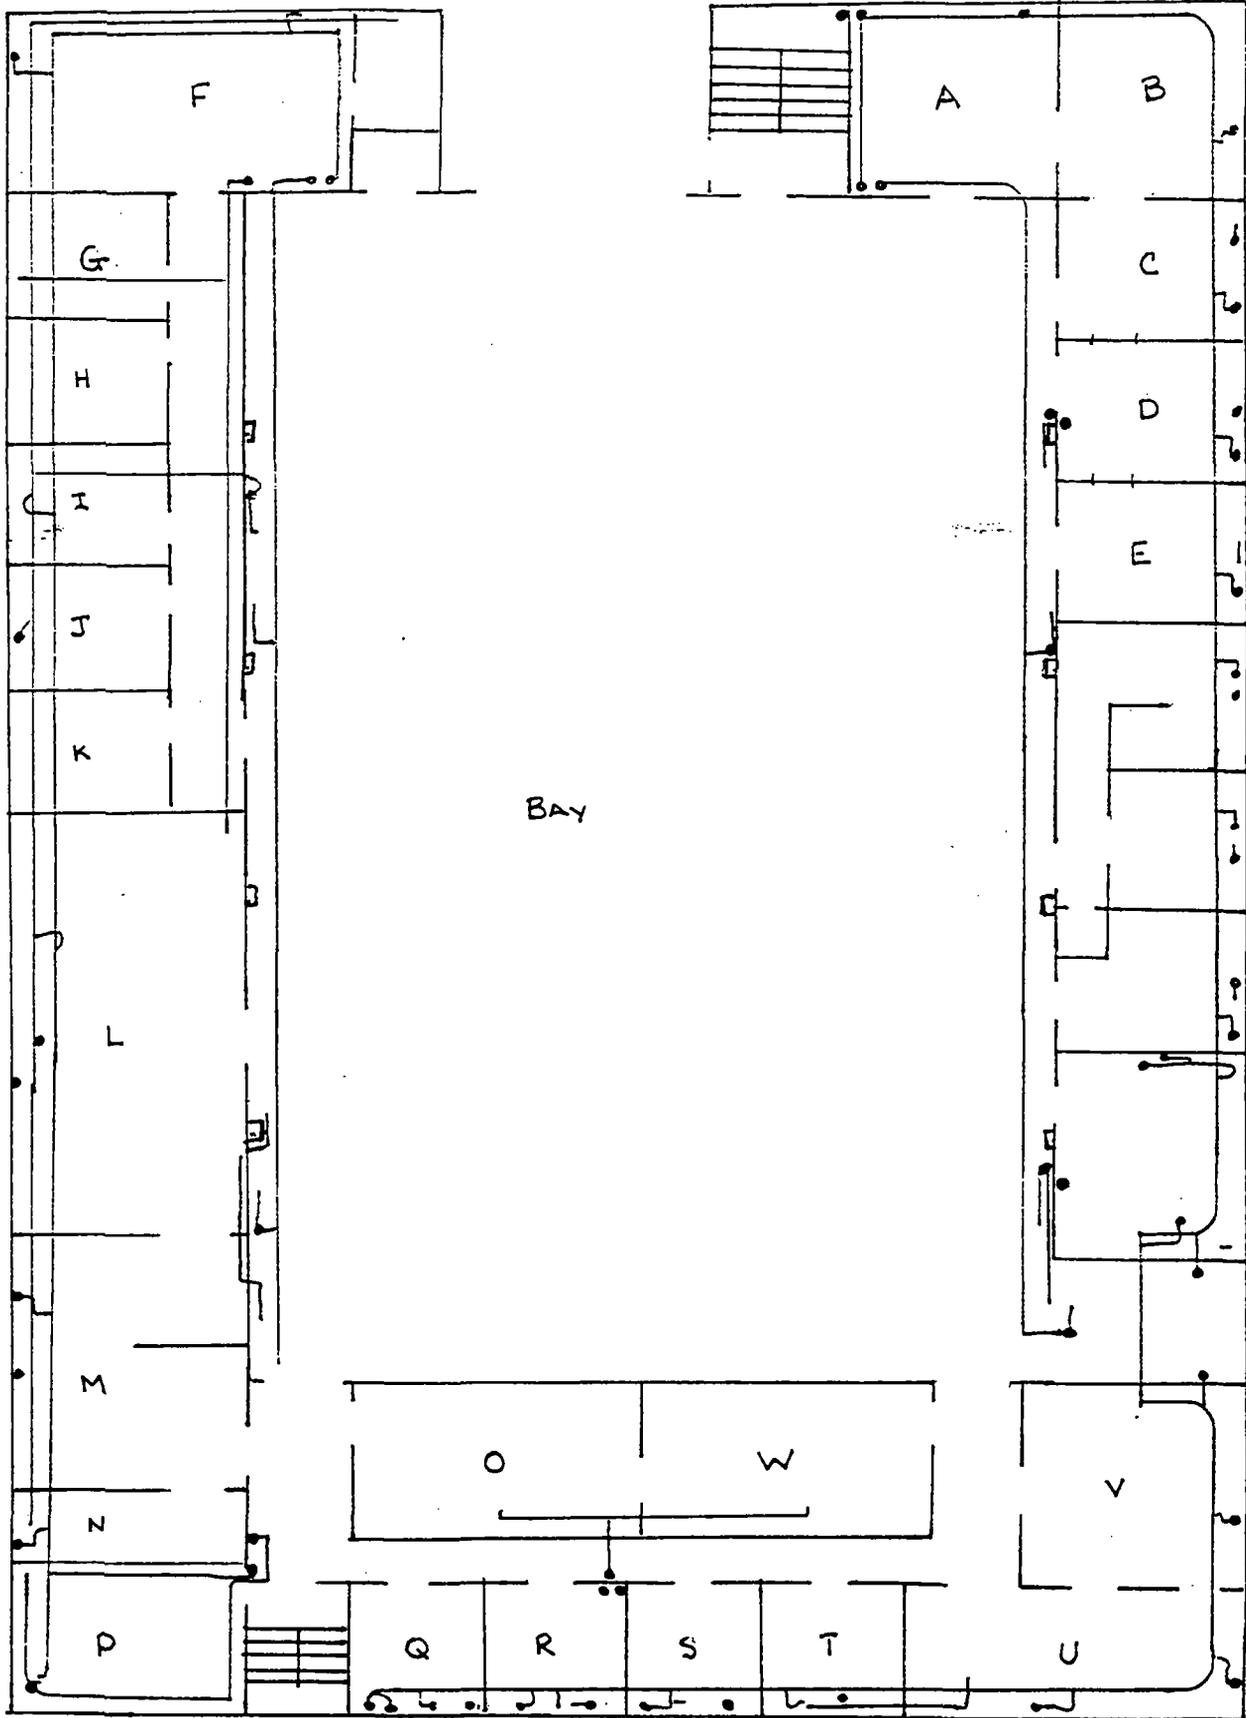
- - Asbestos Riser
- - Asbestos Pipe

The pipe insulation to be removed is located throughout the building in the basement and on the 1<sup>st</sup> and 2<sup>nd</sup> floors. The majority of the pipe insulation will be removed using the glove bag method and the work area will be demarcated with appropriate signage posted. A containment will be constructed if multiple runs of pipe are removed in the same area. Containments will be constructed as a negative pressure enclosure.

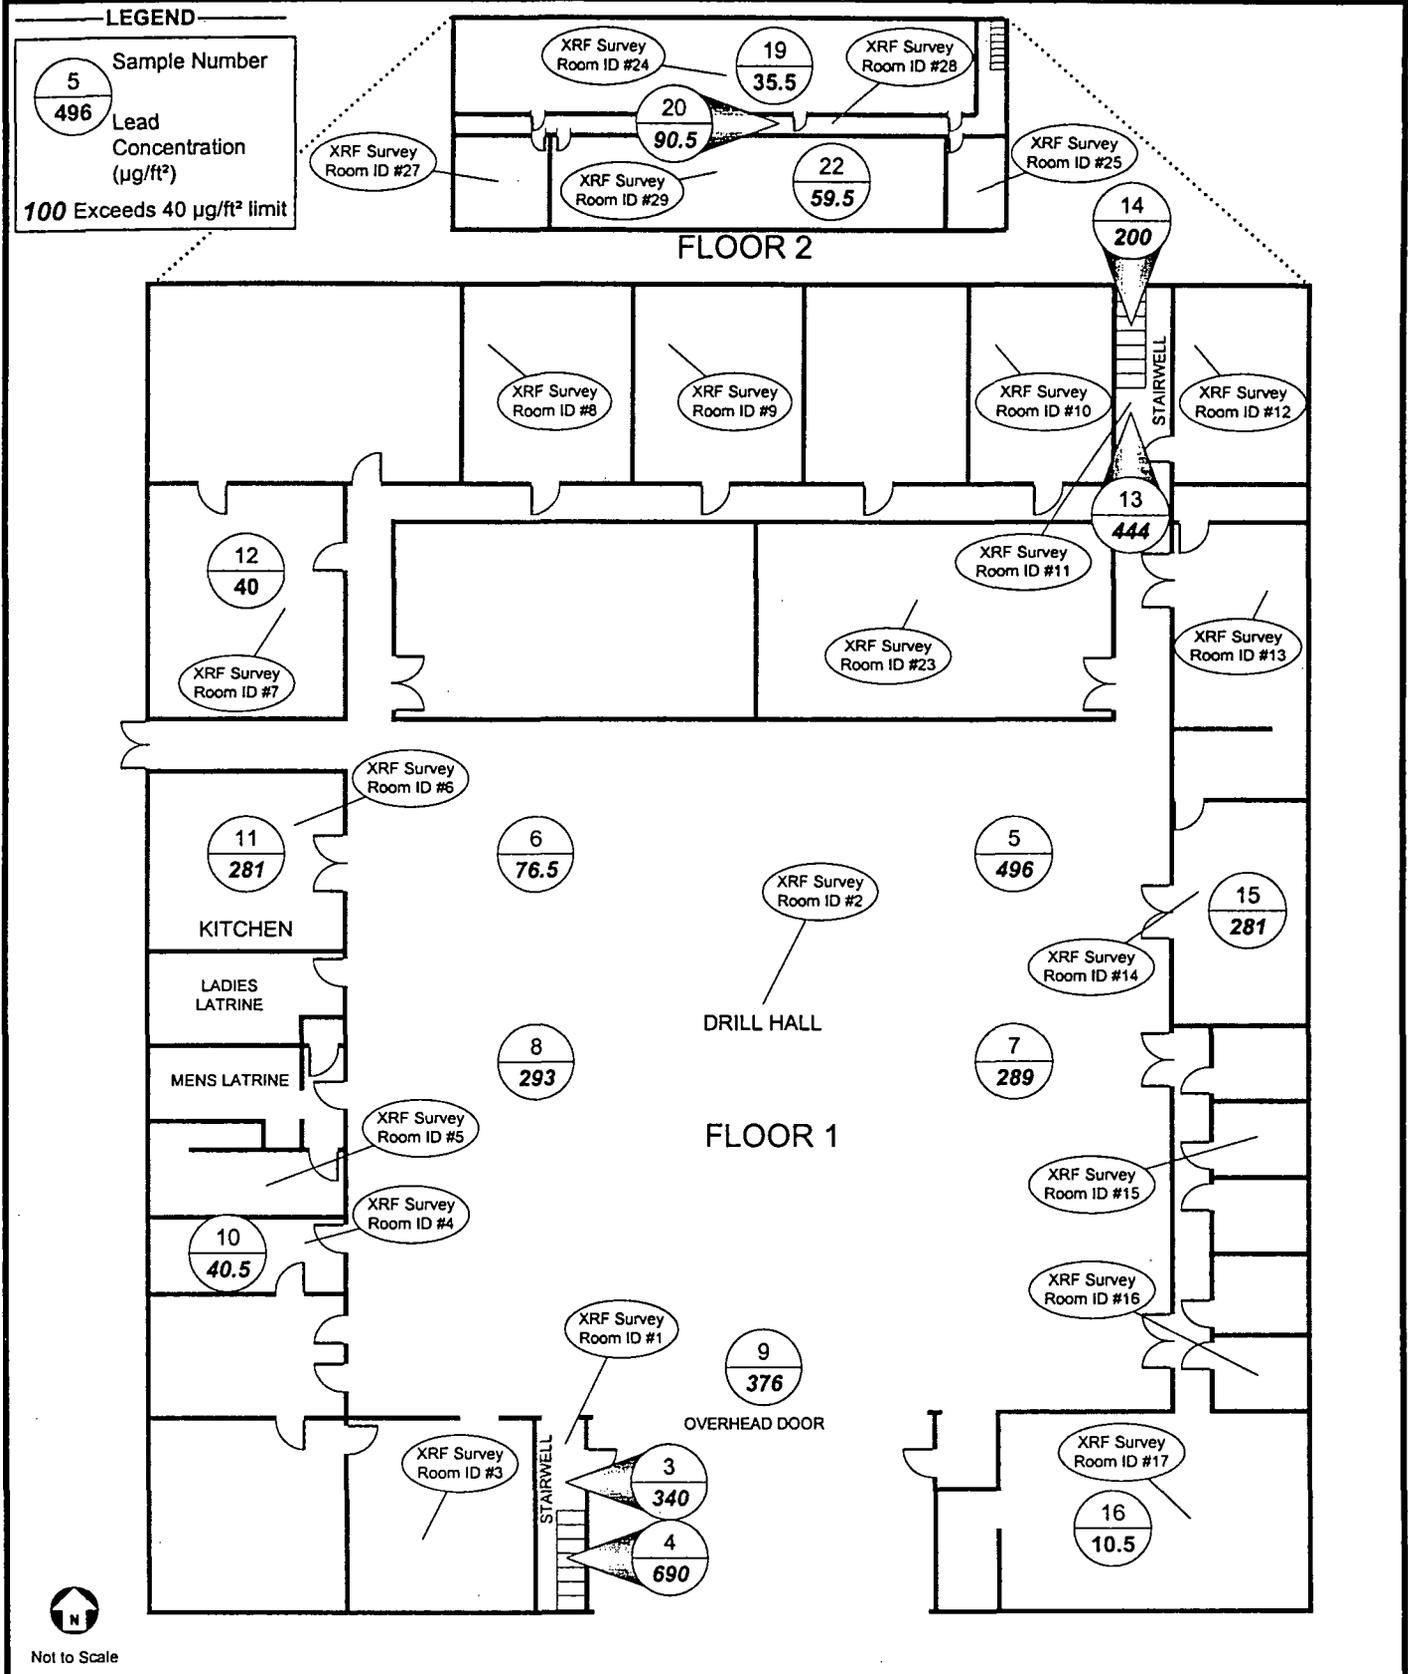
**General Locations of Lead Dust Wipe Samples and Results**  
**SSG Gus Kefurt U.S. Army Reserve Center, 399 Miller Street, Youngstown, Ohio**  
 IT Corporation, Cincinnati, Ohio

A total of 20 samples were secured in 14 areas in the facility. The general sample locations and the results are summarized in the attached table and illustrated on Figures 1 and 2, attached. Two field blanks were also prepared and submitted for analysis. The field blanks were prepared by removing and replacing the cap of the vial in the sampling area.

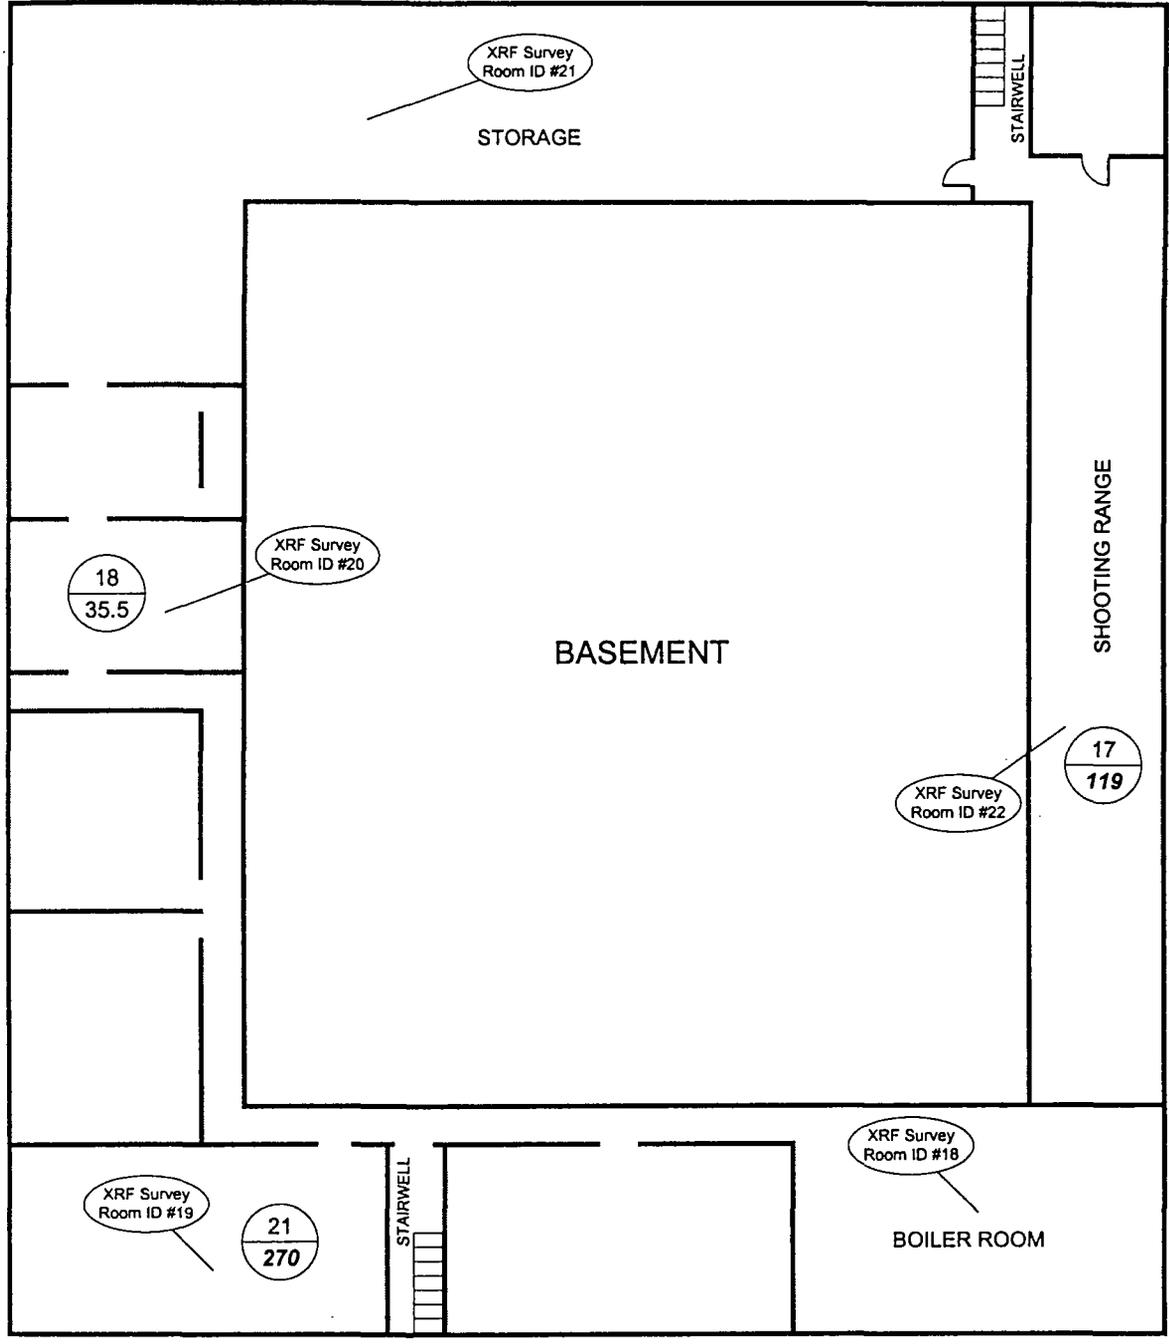
**General Locations of Lead Dust Wipe Samples and Results**  
**SSG Gus Kefurt U.S. Army Reserve Center, 399 Miller Street, Youngstown, Ohio**  
IT Corporation, Cincinnati, Ohio
